POST LAUNCH REPORT

MERCURY-ATLAS NO.1

Project MERCURY

August 2, 1960

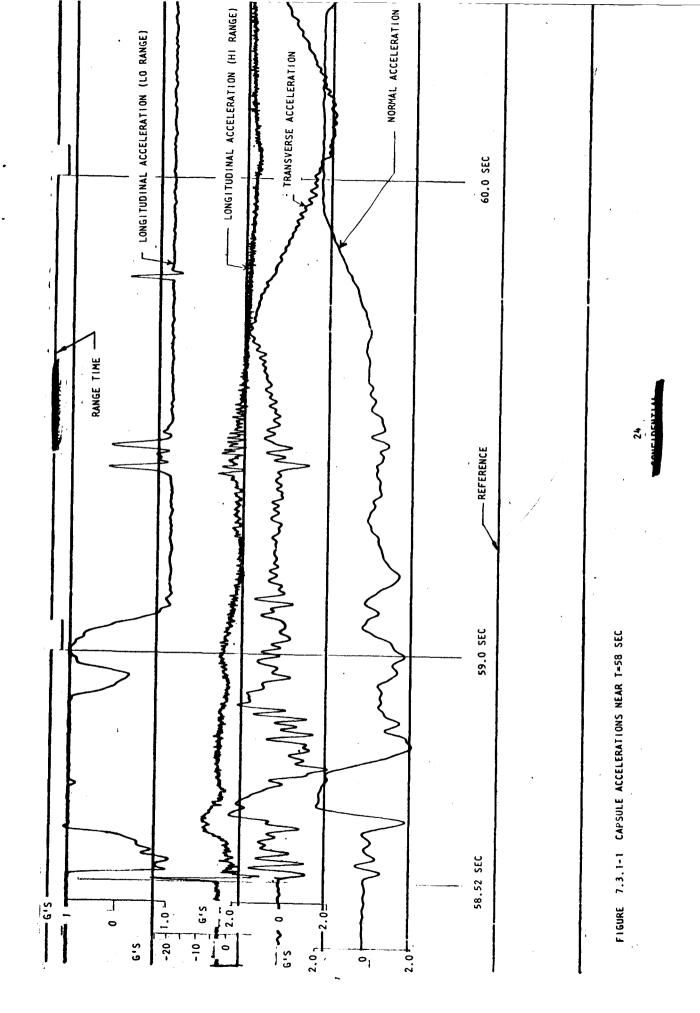
The first indication of any deviation from normal launch angular rates and accelerations occurred at 58,52 sec from 2-inch motion as seen in figures 7.3.1-1 and 7.3.1-2. At this time a negative longitudinal acceleration impulse (in thrust direction) of greater than 25 g's was detected on the high range longitudinal accelerometer. This 25 g negative acceleration was attained at 58.52+0.006 seconds. At 58.52+0.012 seconds a 10 g positive acceleration was This cycle is completed in about 20 milliseconds. The level of longitudinal g's then went to zero for approximately 0.10 seconds then increased to 8 g's thrust for another 0.10 seconds before returning to the booster thrust level. At about 59 seconds the acceleration began to decrease in an irregular manner ultimately reaching a maximum of about 7.5 g retardation (drag). The capsule normal and transverse accelerometers also indicated some side loads of short duration at approximately 58.7 seconds; starting at 59.5 seconds both of these accelerometers evidenced an oscillation of the type that would indicate that the capsule and its possible attached booster parts was a free body. From the angular rate traces in figure 7.3.1-2 an abrupt change of all rates is seen at about 59.5 seconds.

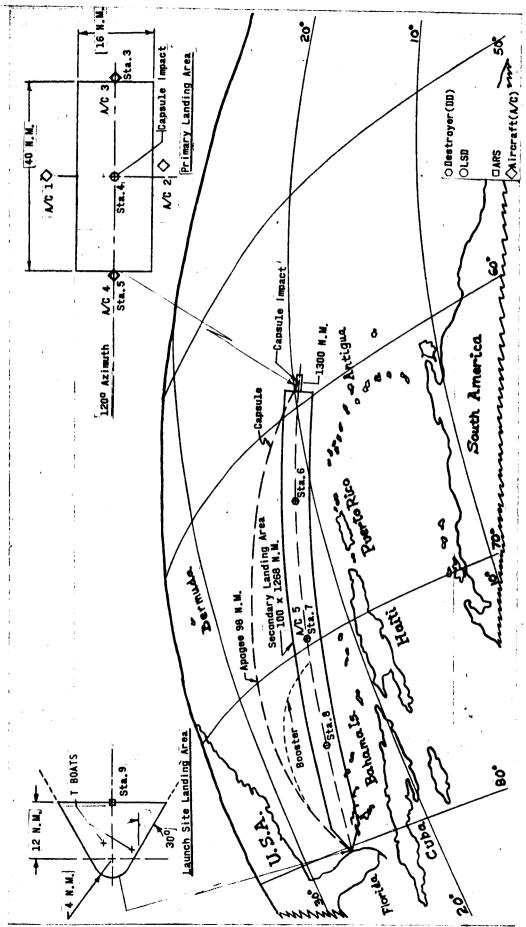
FIGURE 7.5-1 Location of Ship and Aircraft Stations in Designated Recovery Areas.

The distribution of the recovery forces in the designated recovery areas is shown in figures 7.5-1 and 7.5-2. The general plan of action following launch was to transmit (by voice radio) the predicted landing point information from the recovery control center to the downrange recovery commander. The recovery commander would then activate appropriate electronic and visual aircraft search plans to locate the capsule. Following location, capsule pickup would be by either helicopter or ship, whichever could be done more quickly. There were no prelaunch movements of the recovery forces from the planned locations.

At approximately T+140 seconds (8:15 a.m. E.S.T.), the launch site recovery commander in the airborne helicopter was advised that radar was tracking a descending object and to stand by for vectoring to the impact area. The T-boats (see figure 7.5-1) reported no visual sightings and that visibility had deteriorated to  $0-\frac{1}{2}$  mile in rain showers. The helicopter was vectored to an area approximately 7 miles downrange on a bearing of 105 degrees from Pad 14. Radar tracking information and IP 709 and G. E. Burroughs impact predictions indicated the possibility of parts being scattered from 4 to 7 miles downrange. approximately 9:30 a.m. the T-boat from the northern position joined the helicopter in the search area. No indication of capsule or booster impact was found in the area. copter search was maintained (by successive reliefs by the two other helicopters) until approximately 10:30 a.m. sea conditions continued to deteriorate and were reported to be very choppy with 8 foot swells. At 11:00 a.m. the search was temporarily suspended due to the extremely poor search conditions.

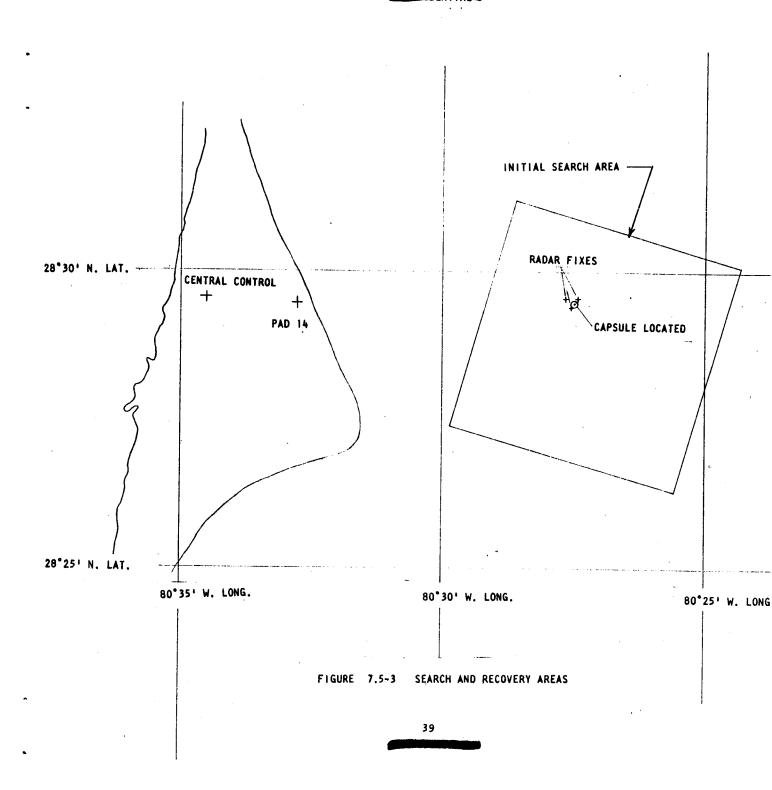
At approximately 12 o'clock the T-boat began recovering capsule parts. Salvage operations were continued until sundown, and approximately 90-95% of the capsule, including all pyrotechnic devices were recovered. The capsule wreckage was located 4.6 nautical miles due east of Pad 14 on the ocean bottom in 60 feet of water. Figure 7.5-3 shows the recovery area. Salvage operations were resumed at 7:00
